KOOTENAI DEVELOPMENT IMPOUNDMENT DAM SEPTEMBER 2011 ROUTINE OWNERS INSPECTION

Prepared for: The Remedium Group

Prepared by: Kurt Hafferman, P.E.

Inspection **D**ate: **S**eptember 29th, 2011 Report **D**ate: January 12th, 2**0**11

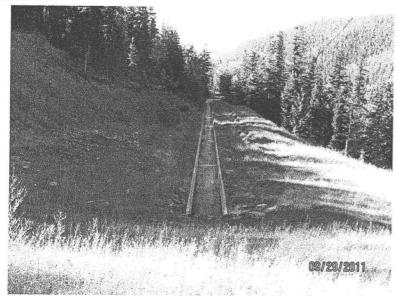
Principal Spillway

No anomalies in the alignment of the dam were noted. No bulges, surface erosion or other physical sign of failure were noted on the site. The principal spillway and emergency spillways are clear with no obstructions and the concrete is in good to excellent condition.

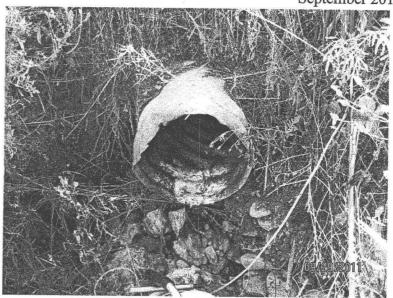
Drain 1

Flows in <u>drain 1</u> have ceased for the season. <u>Drain 2</u> is still running with a decline in flows over last month to less than 1 gpm. It is feasible that drain 2 will cease flows by next month's inspection. Of significance is the black globs of sediment that has been noted at the outlet of the drain and was visibly running in the pipe on August 23rd when a video inspection was carried out on the site. While no continued visual movement has occurred, we continue to see the same deposits at the end of the pipe that indicate this transport may still be intermittently occurring.

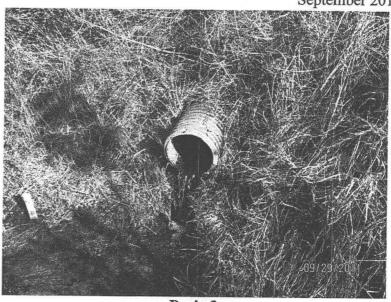
Drain 3

<u>Drains 3 and 4</u> decreased flow again this month. Flows appear to be normal for the time of year and no new material transport has been noted.

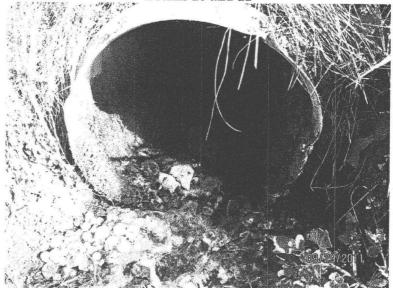
Drains 10 and 11

<u>Drain 10 and 11</u> are at normal flows for this time of year and no anomalies were noted.
